Sleeping Giants

Aboveground Storage Tanks For Non-hazardous Liquids

By Karen Fuentes and Peter Ellis

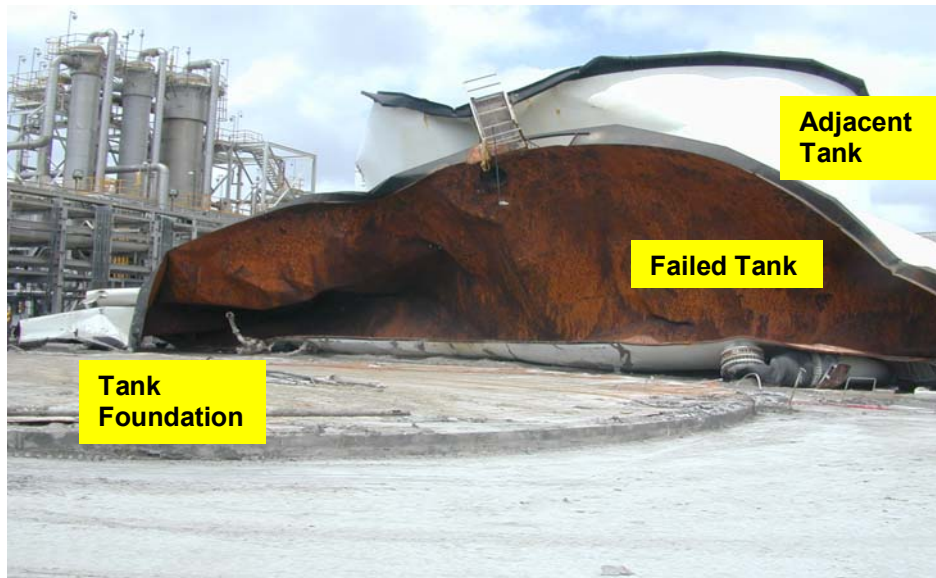
One of several identical roofless 76-foot diameter by 46-foot tall tanks in a stormwater control facility failed catastrophically in 2001, less than 10 years after it was constructed. The collapse (Figure 1) occurred after several days of rain had filled the tank nearly to capacity. The rupture extended the vertical height of the tank and ran around the circumference at the weld between the wall and floor. The 1.6-million gallon flood of suddenly released stormwater knocked two adjacent empty tanks of similar size off their foundations (Figure 2) and damaged nearby electrical trays and piping. As the walls of the collapsing tank unfurled, they impacted a third nearby tank, causing additional damage.

Figure 1. Sides of failed tank lying against adjacent tank.

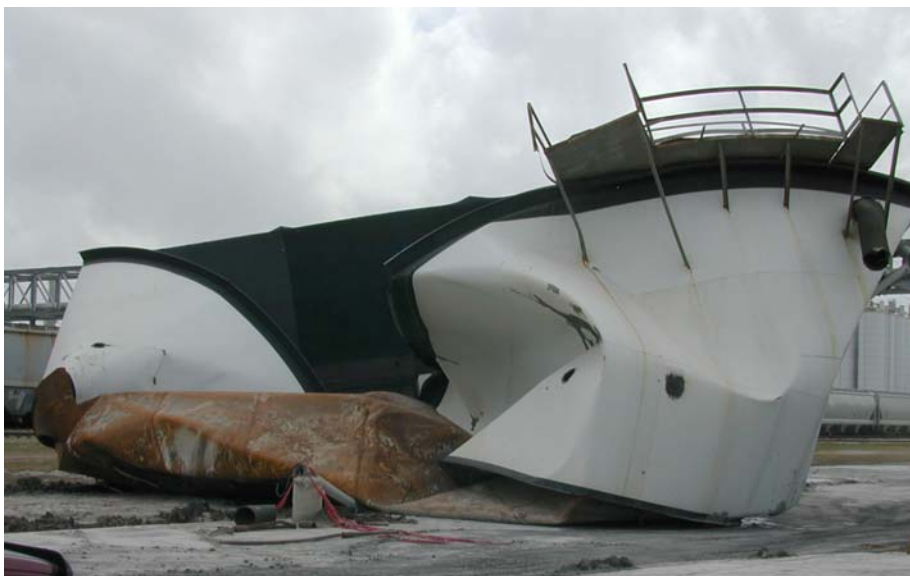
Figure 2. Tank near failed tank that was damaged by released storm water.

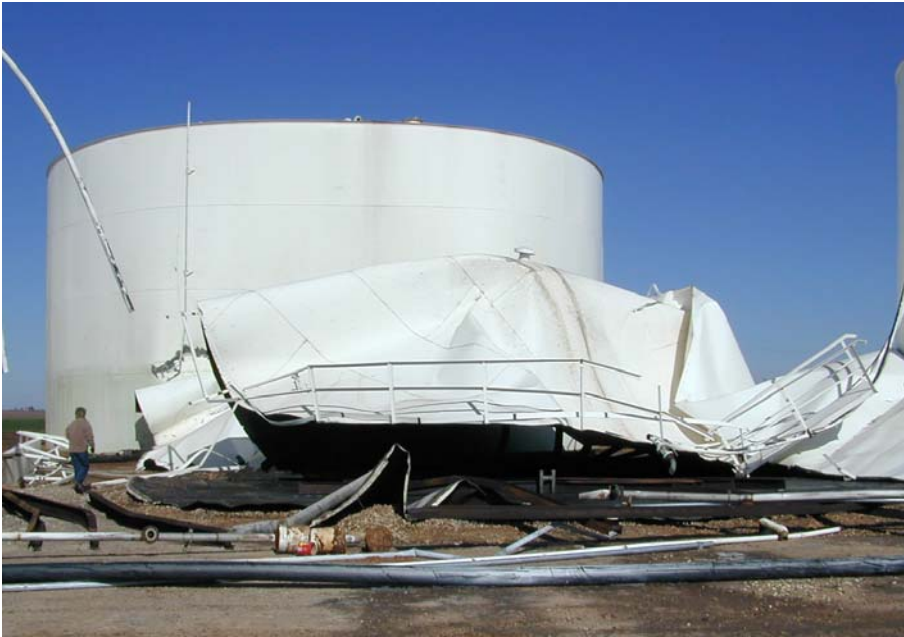
when it was filled in the spring of 2003. The shell split vertically and tore from the bottom around the circumference of the tank, collapsing the tank (Figure 3), spilling 500,000 gallons of fertilizer, and damaging three surrounding storage tanks (Figure 4).

Figure 3. Failed liquid fertilizer storage tank.

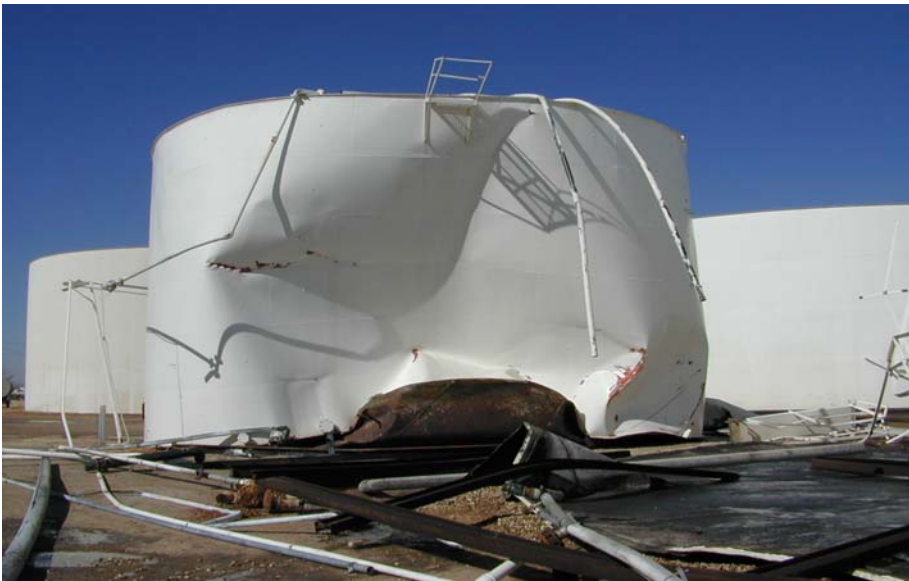
Figure 4. Damage to an adjacent tank caused by the impact of the unfurling wall of the failed tank.

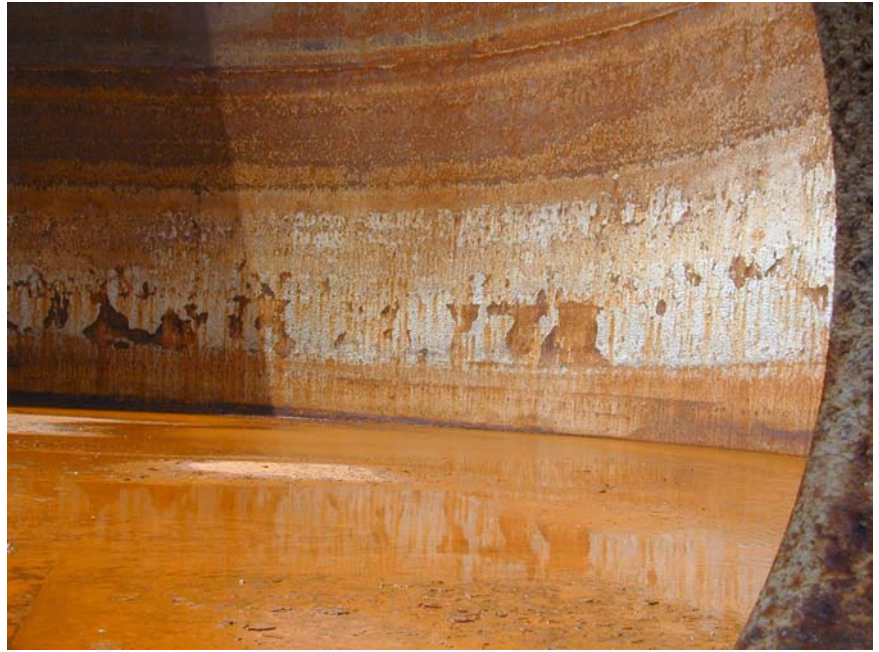
It is generally known that corrosion in the sorts of solutions stored in unlined carbon steel tanks may be three to ten times greater at the liquid line than elsewhere in the tank, resulting in a band of deeper corrosion and “rust ring” at the typical or average liquid level. In each of the failures investigated, M&M Engineering found that the rust ring was near the bottom of the tank (Figure 5). M&M Engineering found that the ruptures occurred because the remaining wall thickness in the “rust ring” could not support the weight of the liquid when the tank was filled. Once the rupture of the thinned area began, the crack ran the length of the tank wall and the circumference of the bottom weld before the potential energy of the stored liquid was spent.

Figure 5. Inner wall of a storm water storage tank.

At this time, review of API and/or STI standards are recommended for organizations concerned about the inspection and evaluation of aboveground storage tanks containing non-hazardous materials.

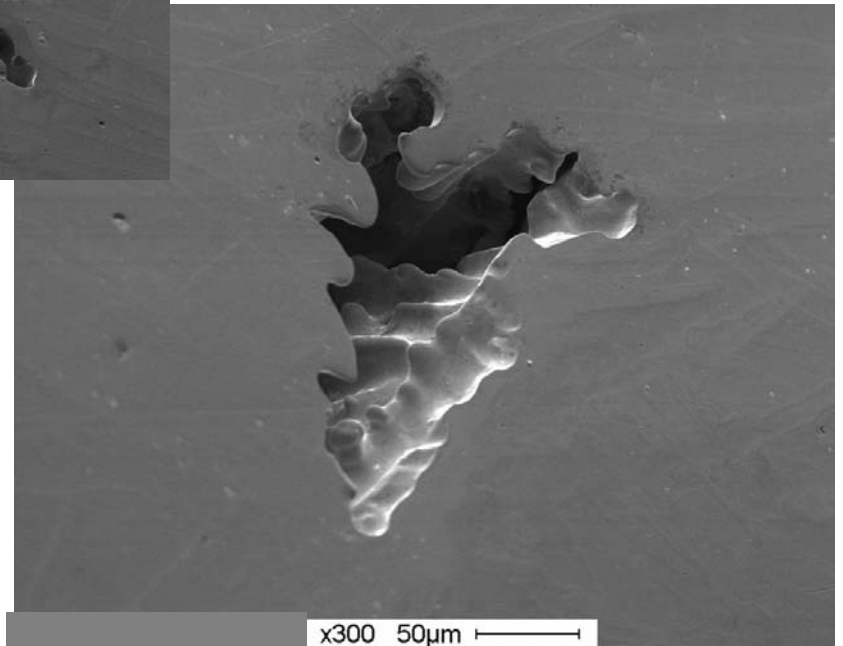
Casting Shrinkage Porosity

Casting voids found in a ring during examination in a scanning electron microscope (SEM).
